TRANSPORTATION RESEARCH CENTER

ON-SITE AIR BAG INVESTIGATION

CASE NO. - 94-09

**U.S. Department of Transportation
National Highway Traffic Safety Administration
National Center for Statistics and Analysis
Washington, D.C. 20590**

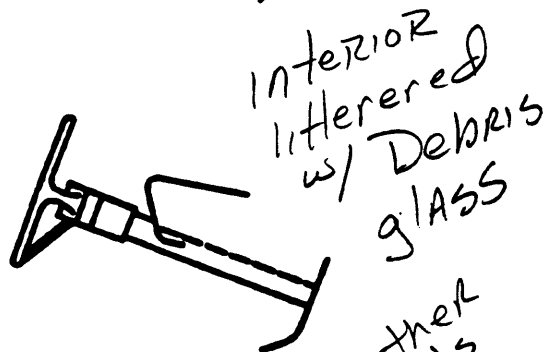
NO other contacts CAN be found

Door w/ Panel torn away during Extraction

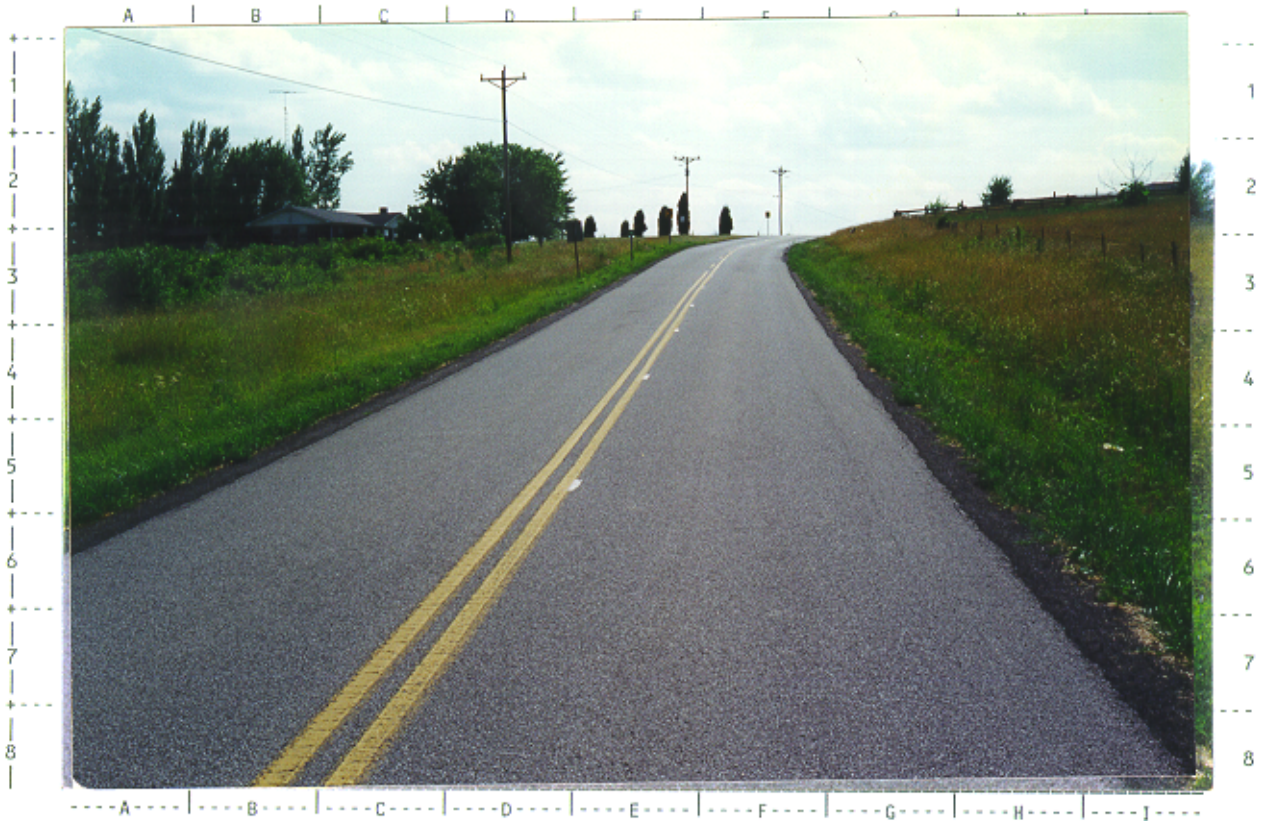
01 -- 1991 Chevrolet Corsica's westward, uphill (grade ~ 9 %), path of travel approximately 120 meters east of first harmful event

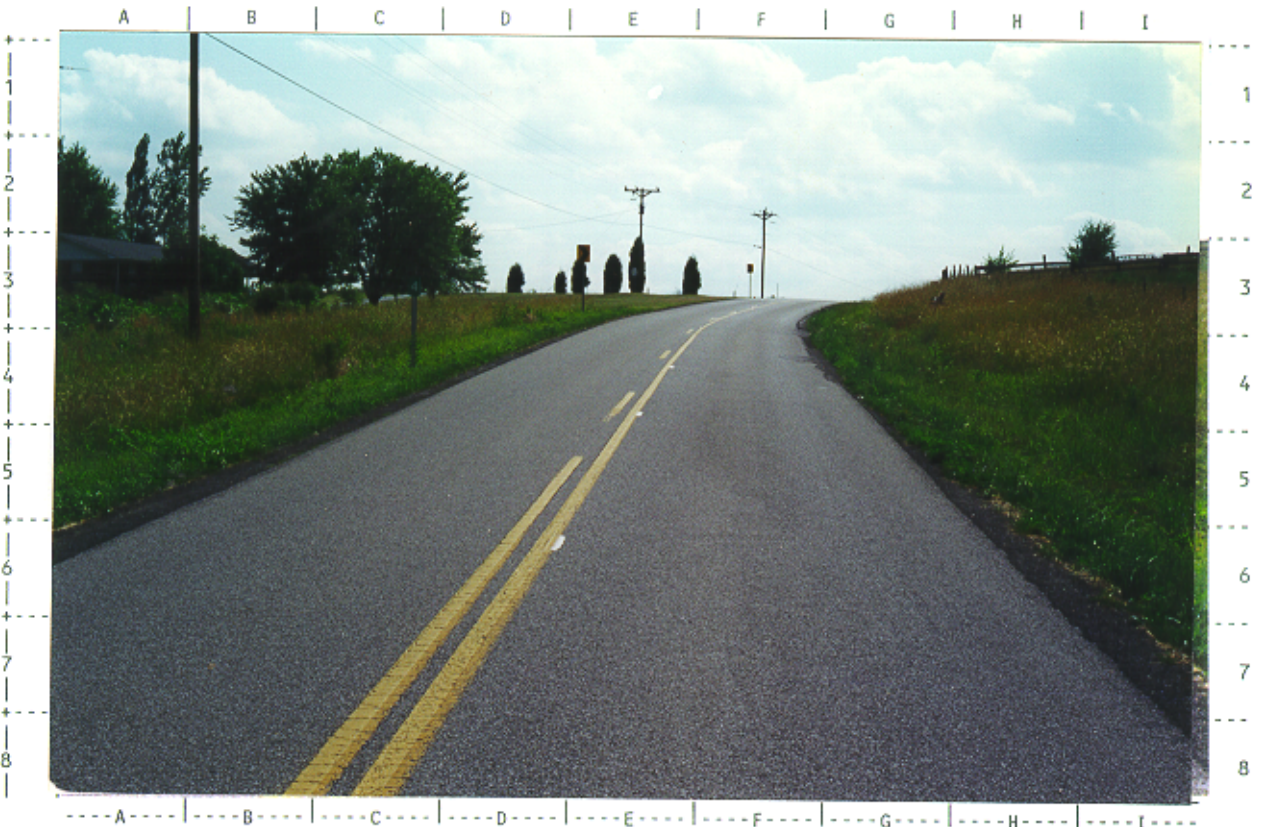
02 -- 1991 Chevrolet Corsica's westward, uphill (grade ~ 9 %), path of travel approximately 85 meters east of first harmful event

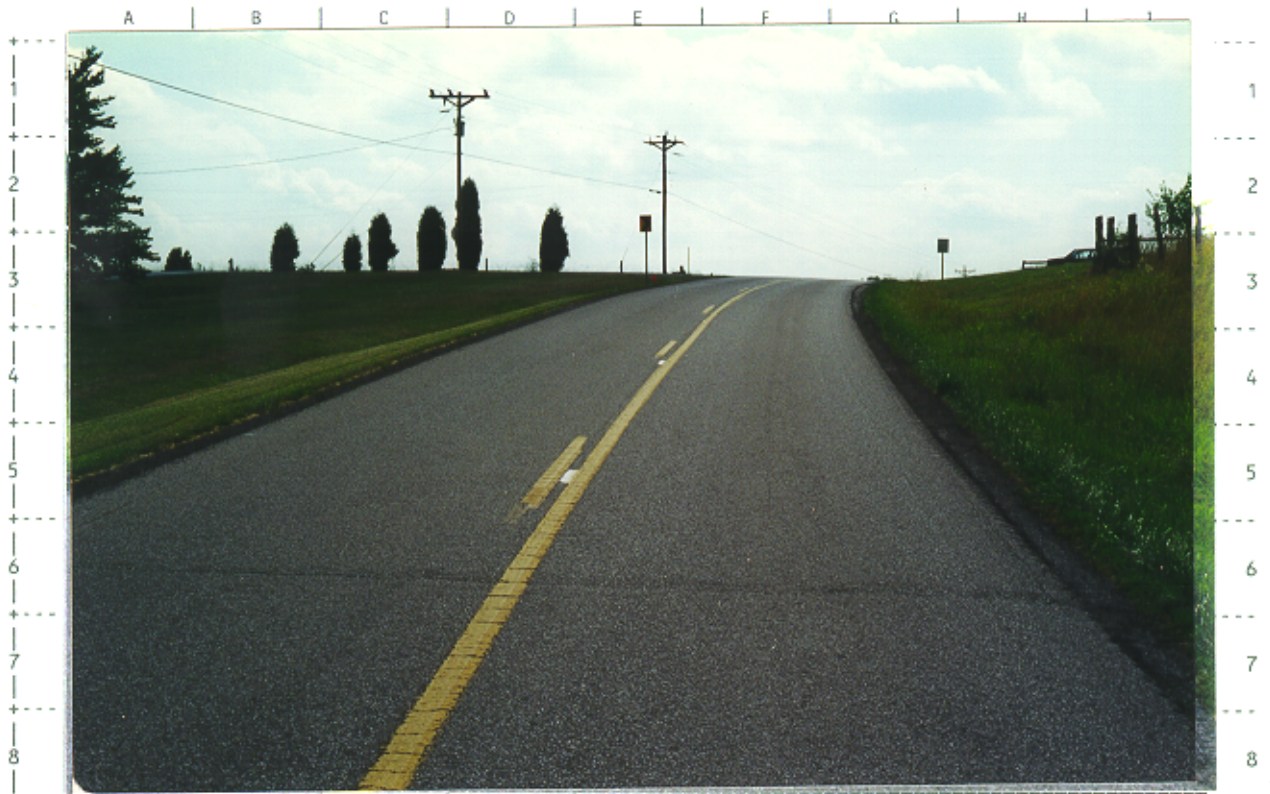
03 -- 1991 Corsica's westward, uphill (grade - 9 %), path of travel ~ 65 meters east of POI & west of right-hand curve's beginning

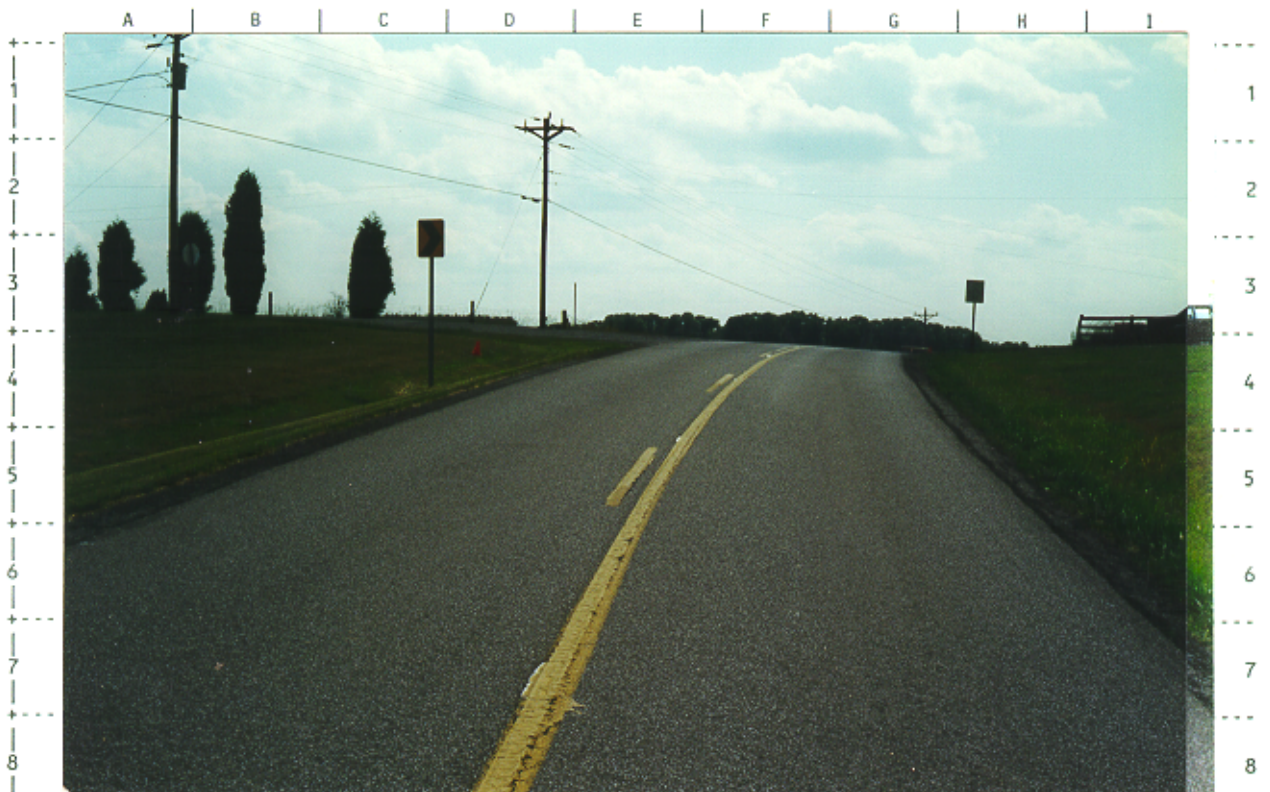
04 -- 1991 Corsica's westward path of travel as Corsica crosses over centerline in right-hand curve-- ~ 30 meters east of POI

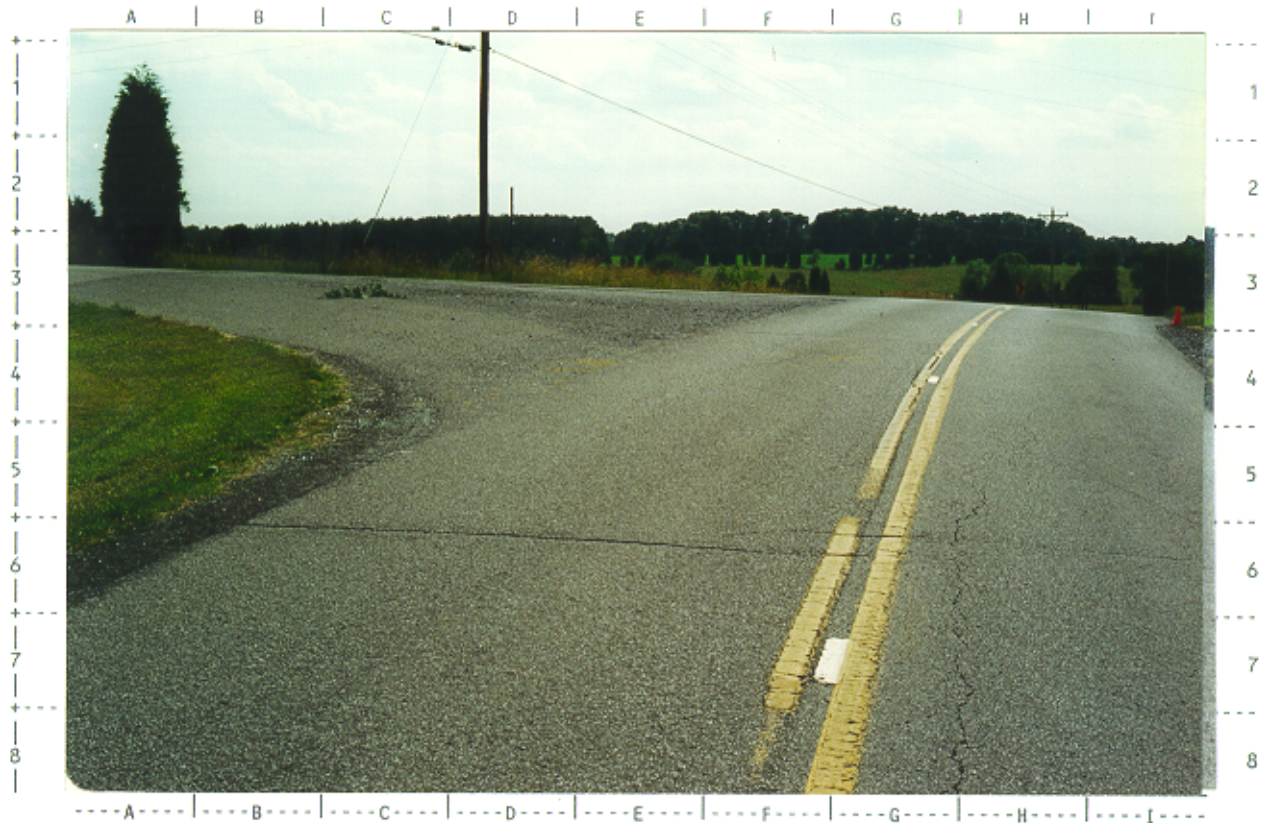
05 -- 1991 Corsica's westward travel path as Corsica enters eastbound lane - 10 meters east of POI; NOTE: orange cone marks FRP area

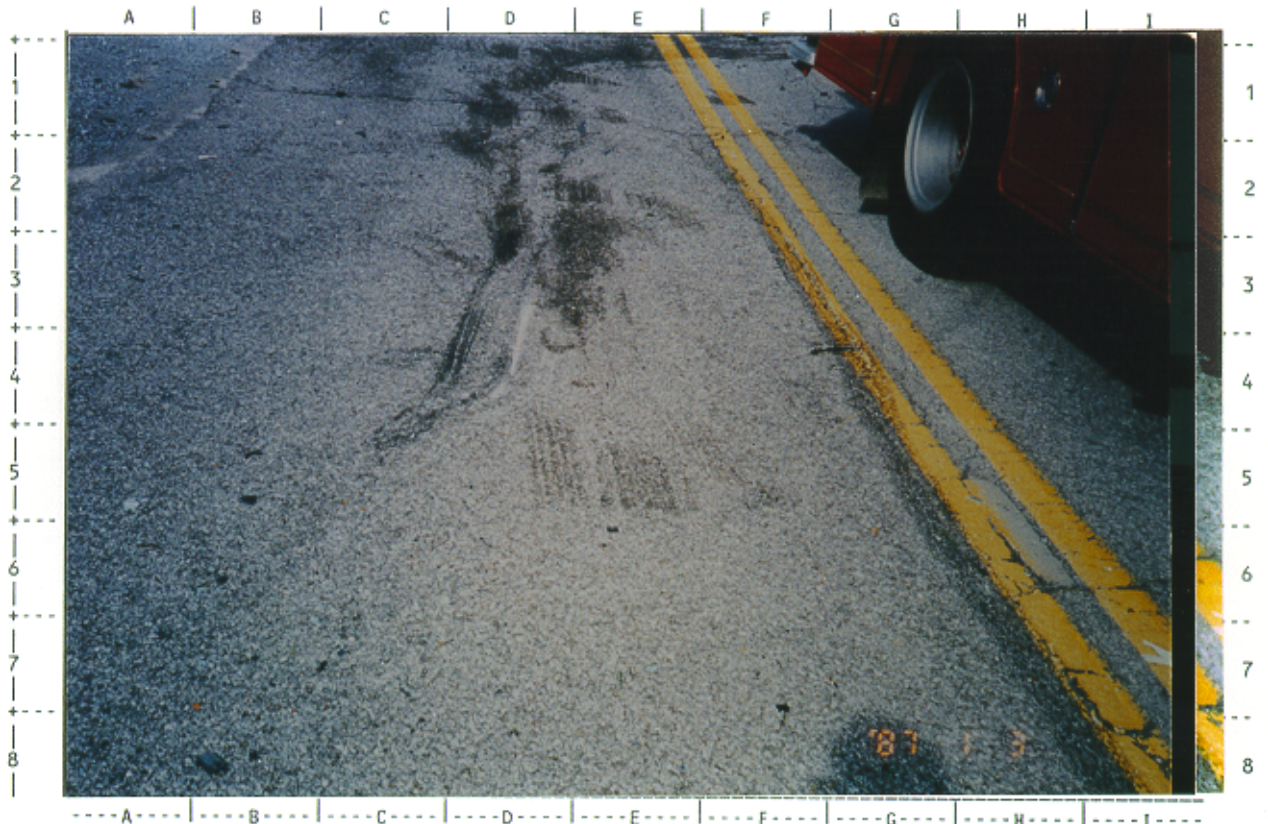
06 -- On-scene view of 1988 Chevrolet C-1500 pickup's left front skid-mark and point of deflection looking west in eastbound lane

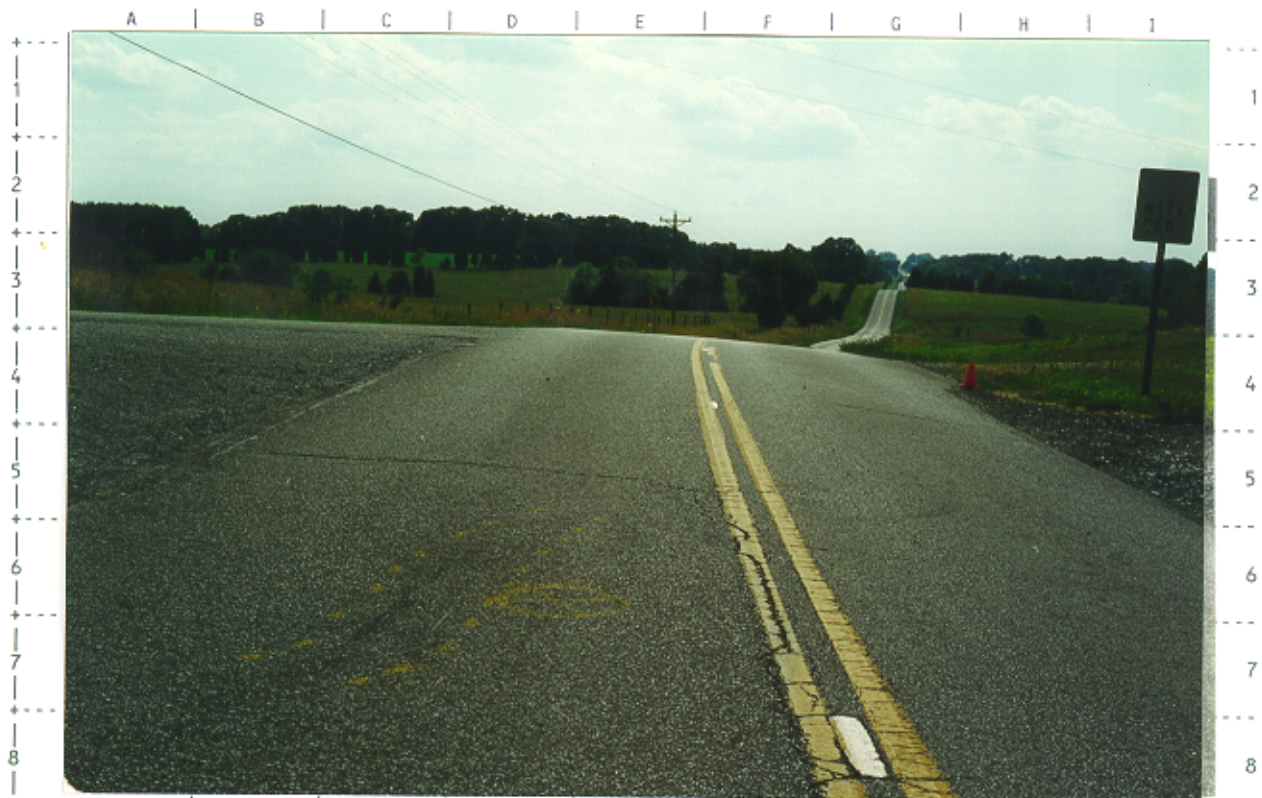
07 -- Westward view of POI (circle) in eastbound lane & 1988 pickup's skidmark (dash crayon); NOTE: orange cone marks FRP area

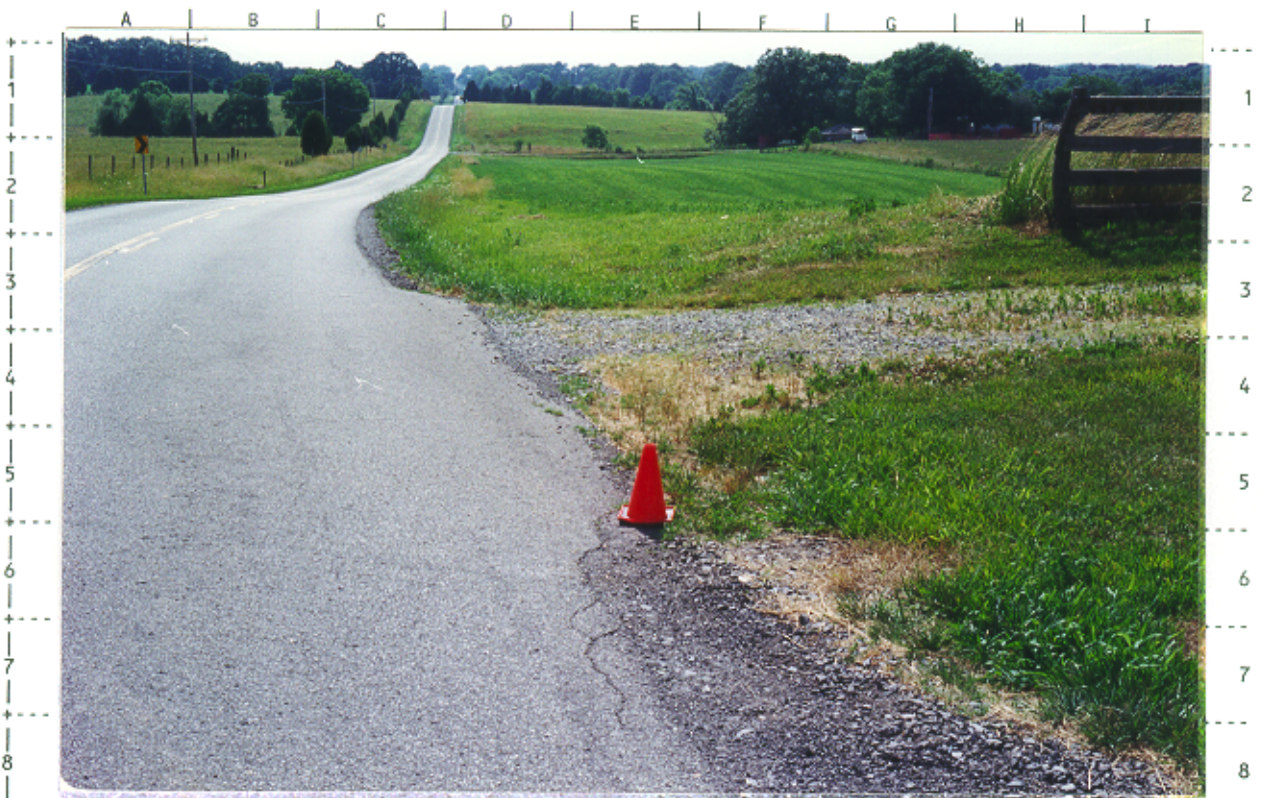
08 -- 1991 Chevrolet Corsica's approximate final rest position area looking west

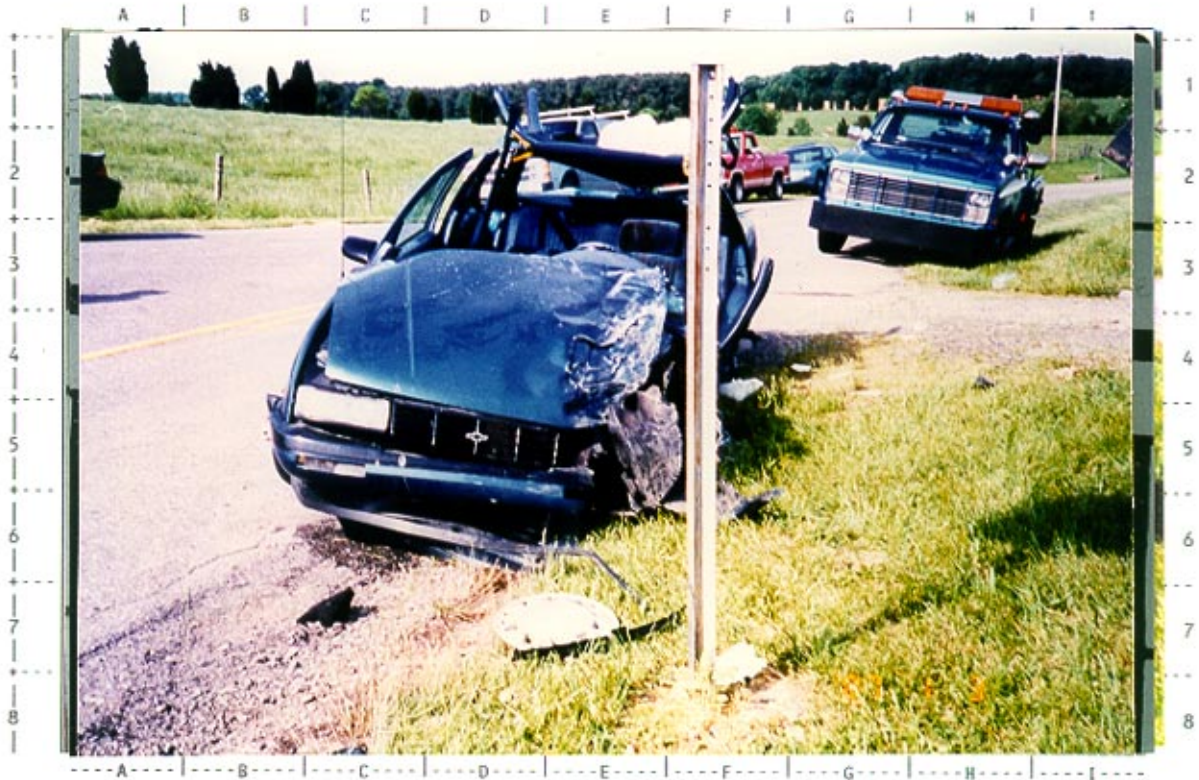
09 -- On-scene view of 1991 Chevrolet Corsica's final rest position looking west--Chevrolet is heading east at FR on north shoulder

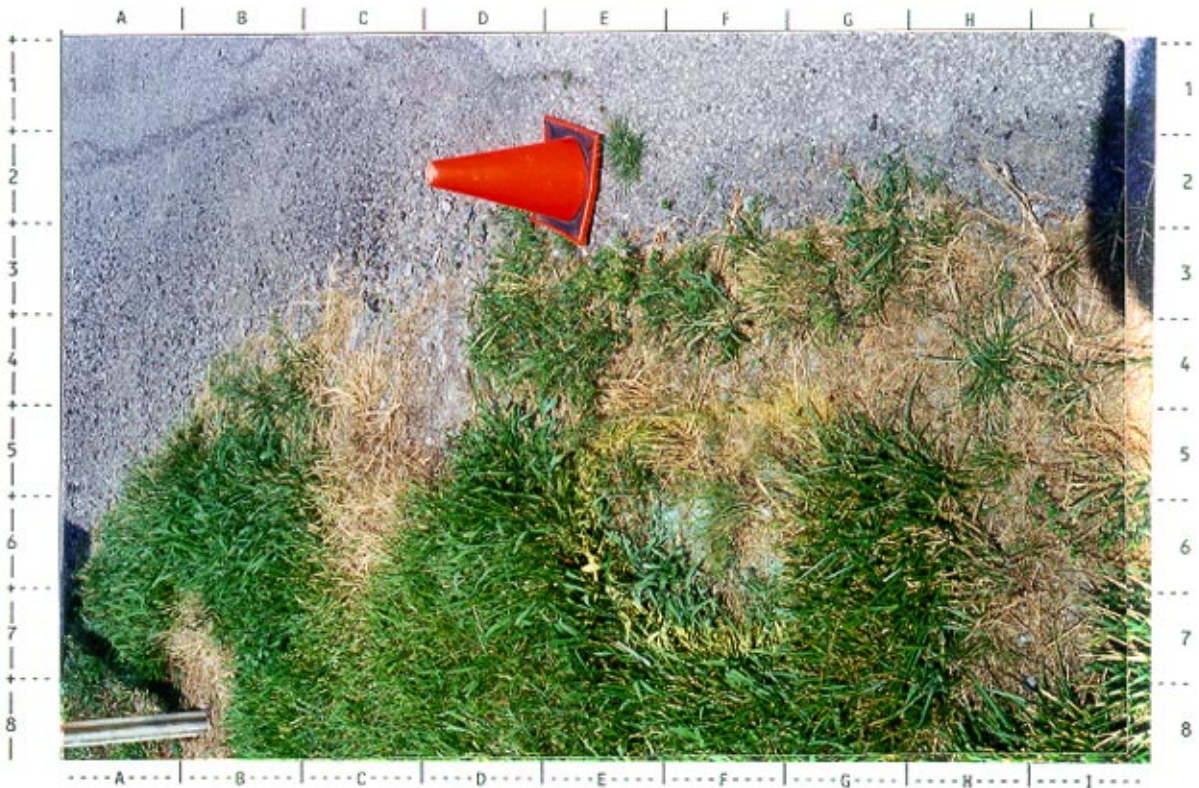
10 -- View of glass (see cells F6--G6) at final rest position of 1991 Chevrolet Corsica

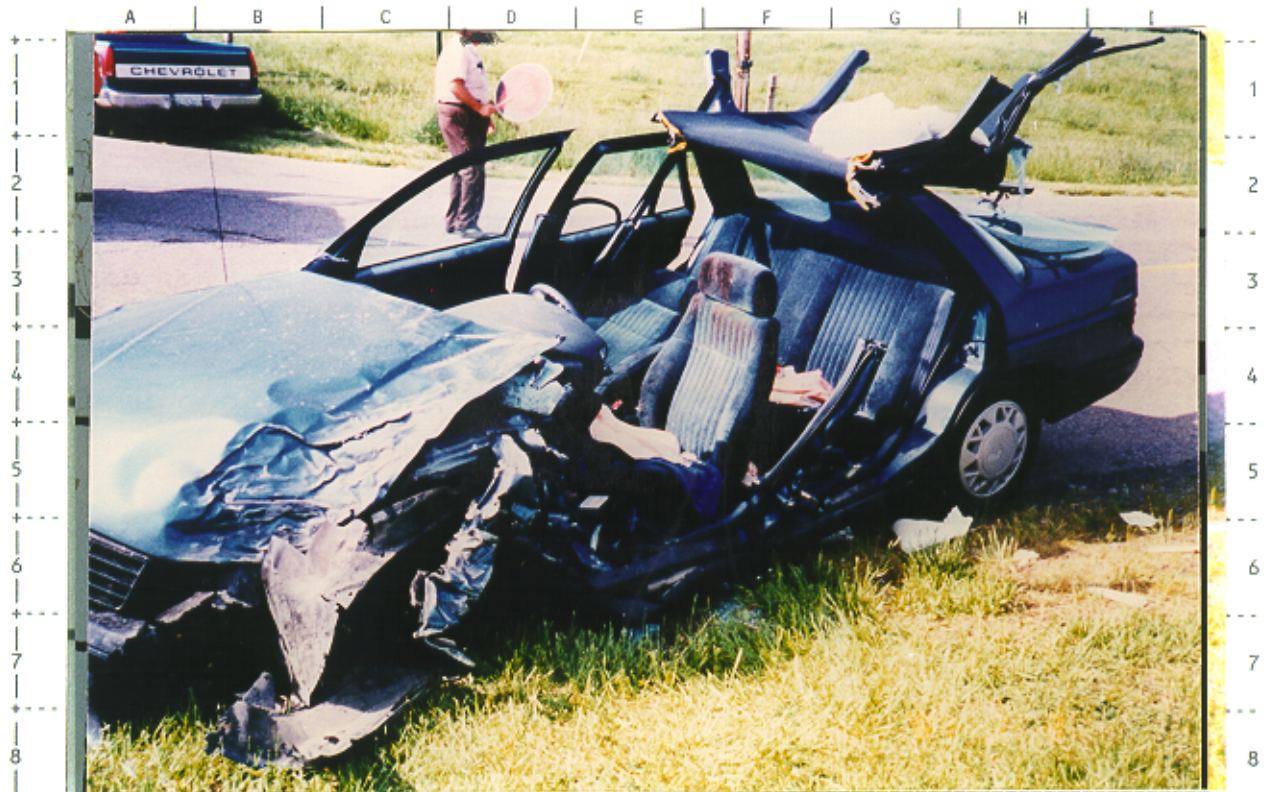
11 -- On-scene southwest view of 1991 Chevrolet Corsica at final rest after driver's extraction; NOTE: cut left B-pillar & blood

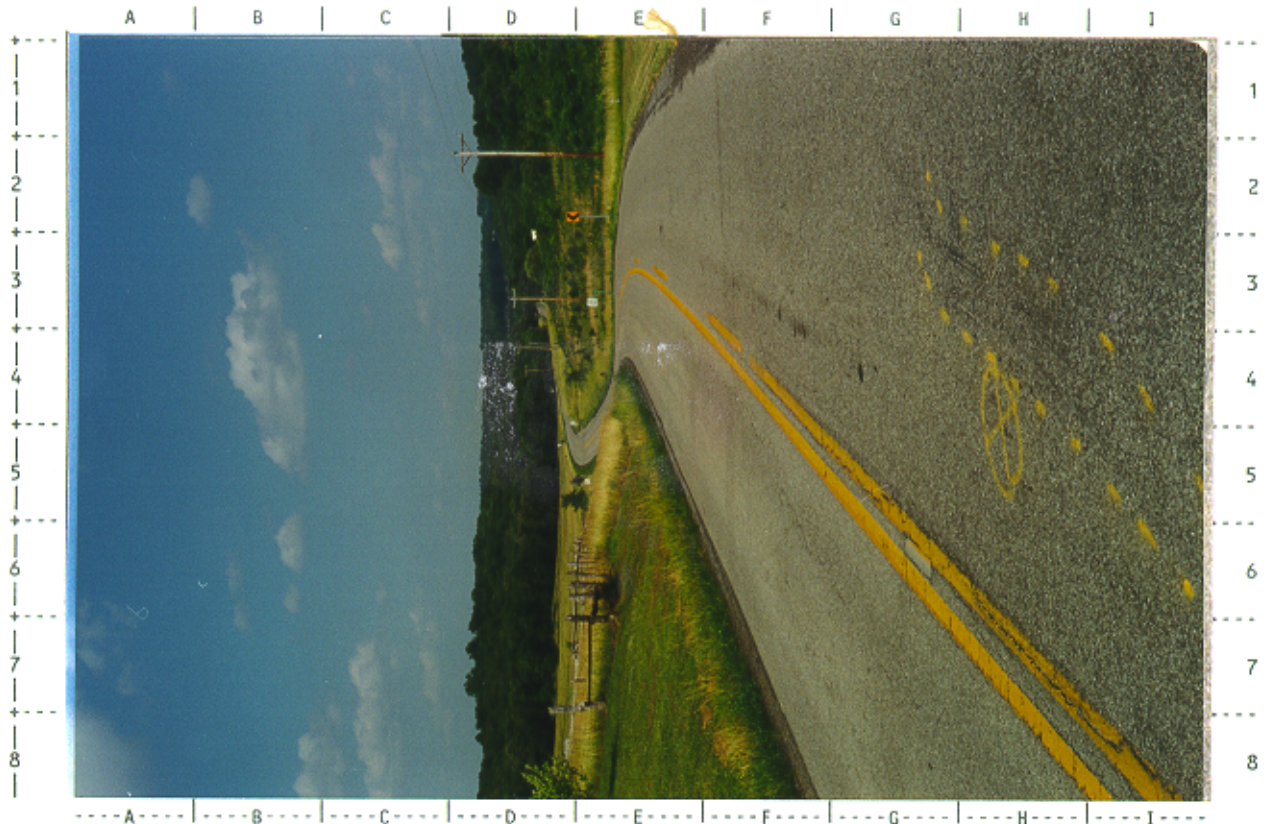
12 -- Looking back (eastward) at 1991 Chevrolet Corsica's path of travel from point of impact

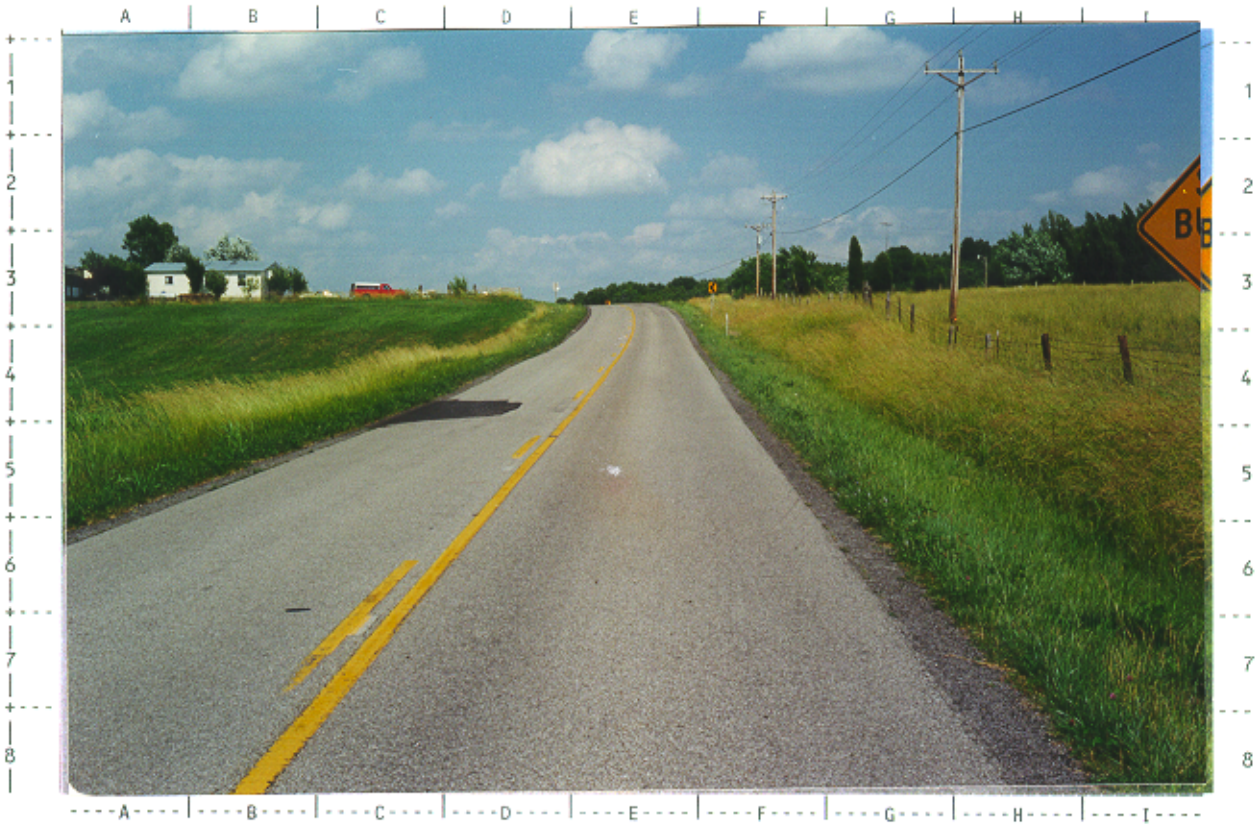
13 -- 1988 Chevrolet C-1500 pickup's eastward, uphill (grade ~ 4 %), path of travel approximately 100 meters west of point of impact

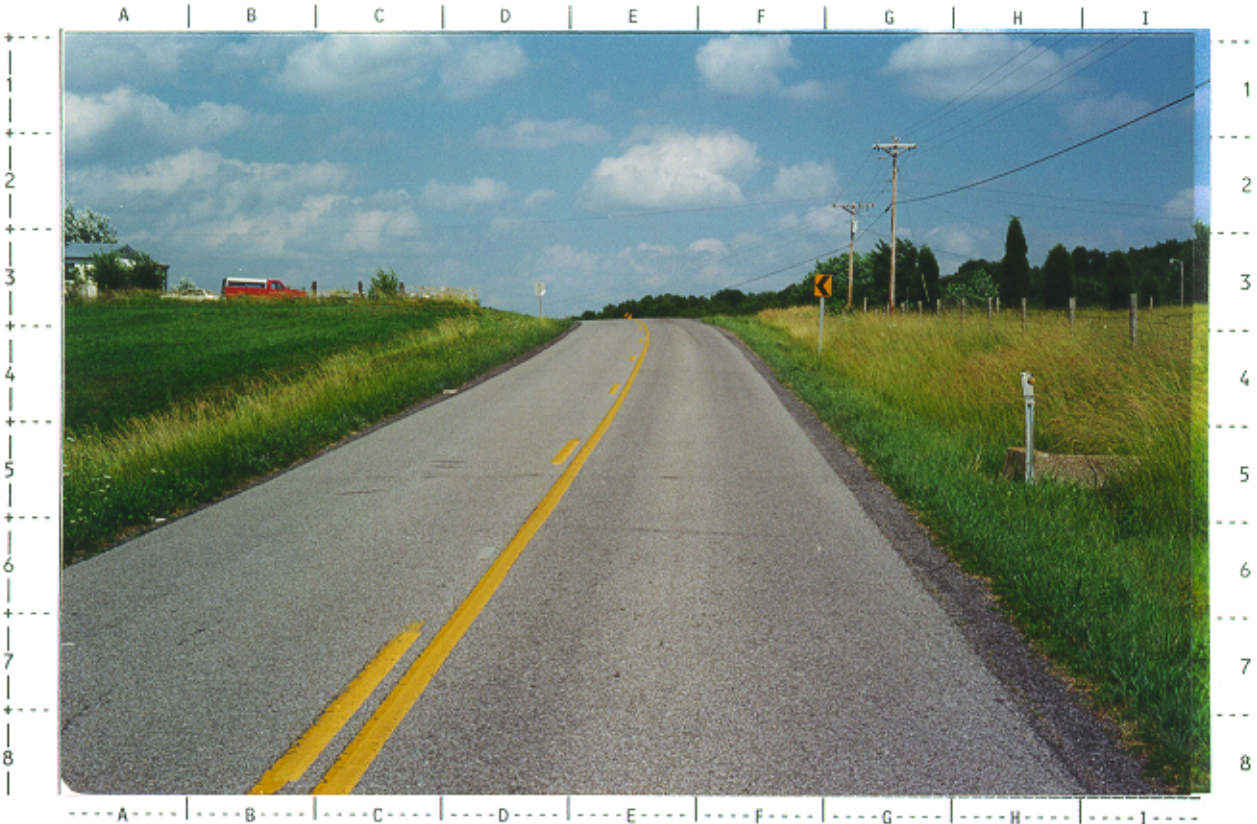
14 -- 1988 Chevrolet's eastward, uphill (grade ~ 4 %), travel path ~ 70 meters west of POI & east of left-hand curve's beginning

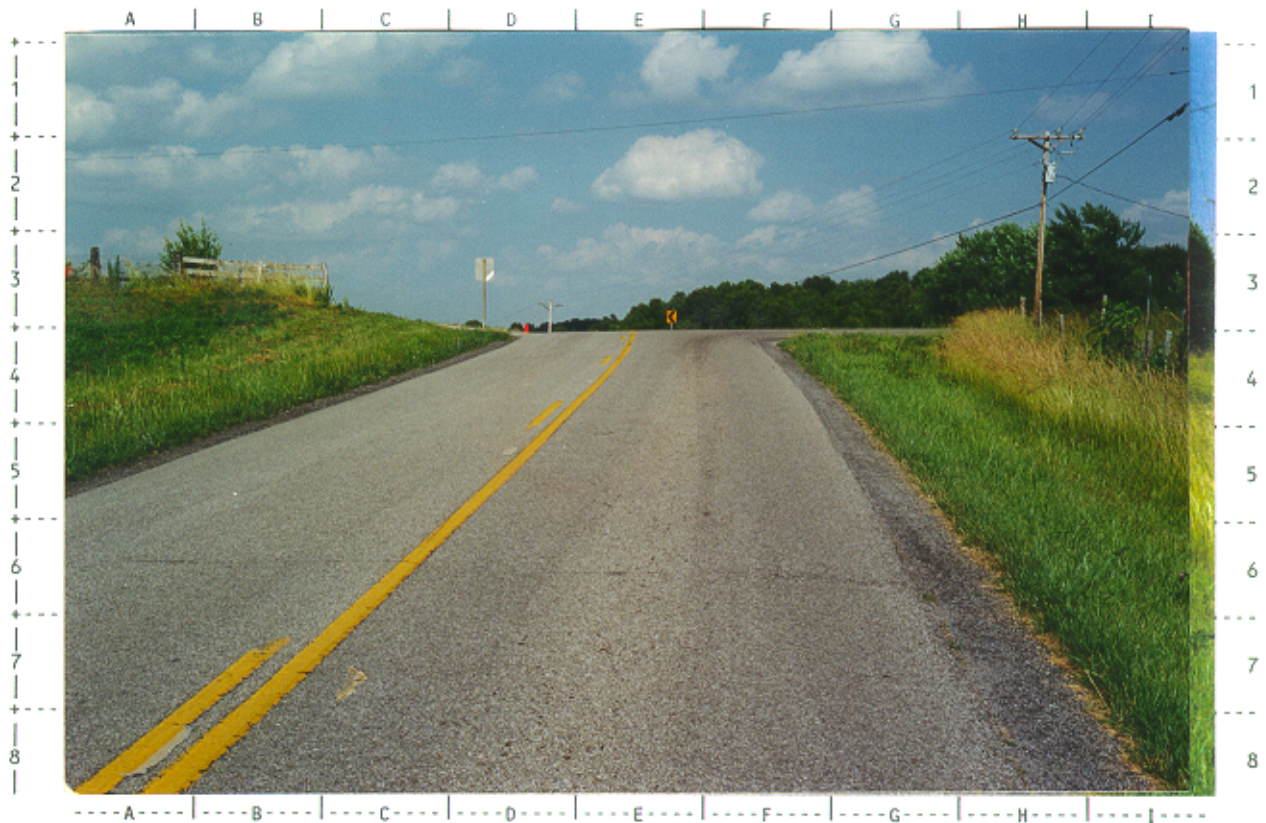
15 -- 1988 Chevrolet's eastward, uphill (grade ~ 4 %), travel path, in the left-hand curve, ~ 45 meters west of point of impact

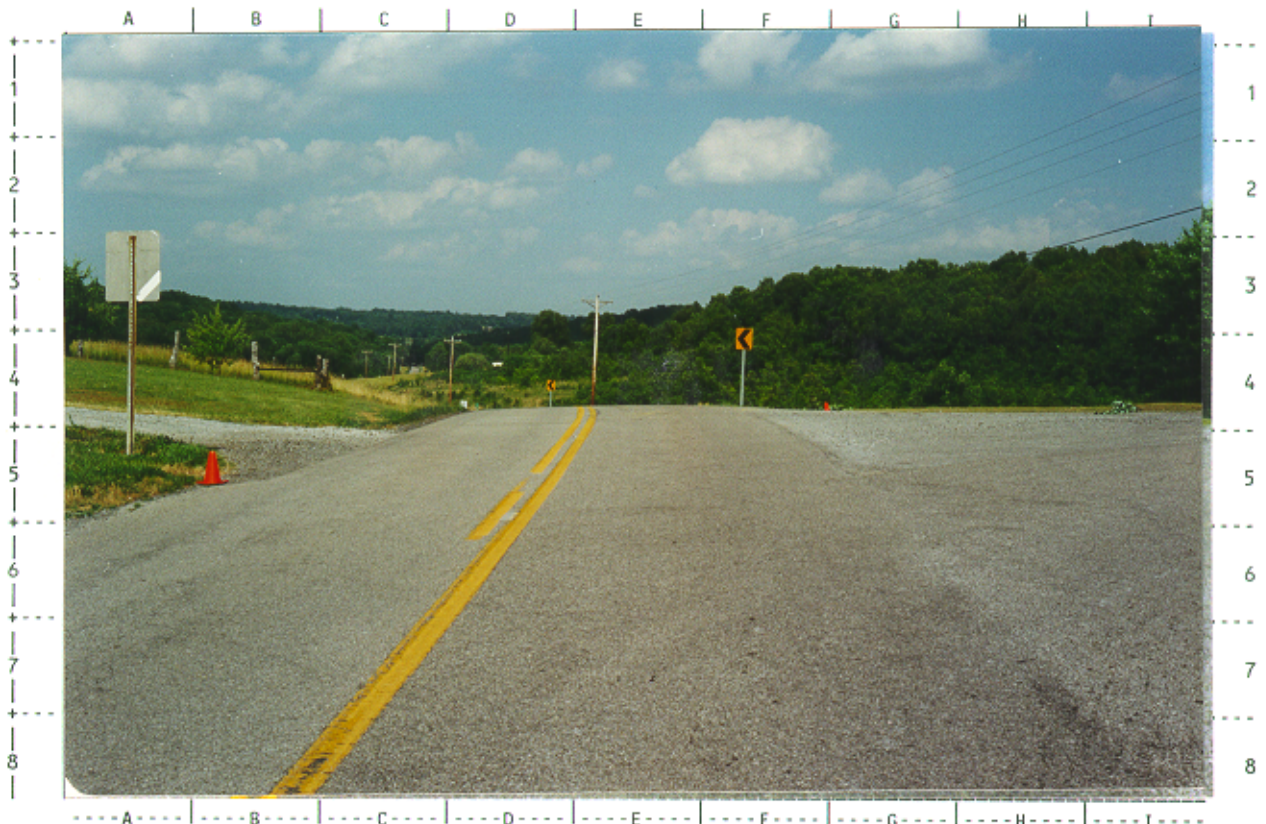
16 -- 1988 Chevrolet's eastward travel path near hillcrest ~ 20 meters west of POI; NOTE: orange cone marks Corsica's FRP (cell X#)

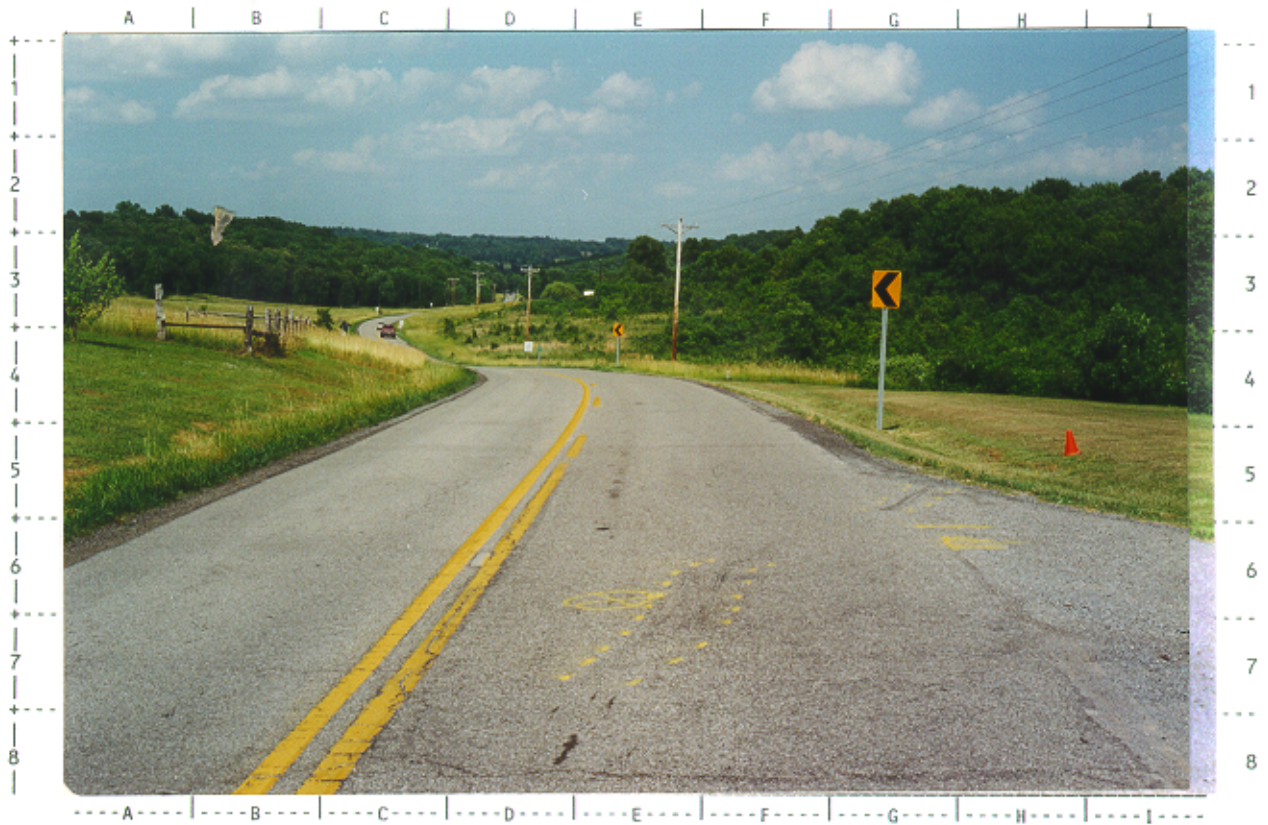
17 -- 1988 Chevrolet's eastward travel path after cresting hill near impact realization point; NOTE: orange cone marks FRP area

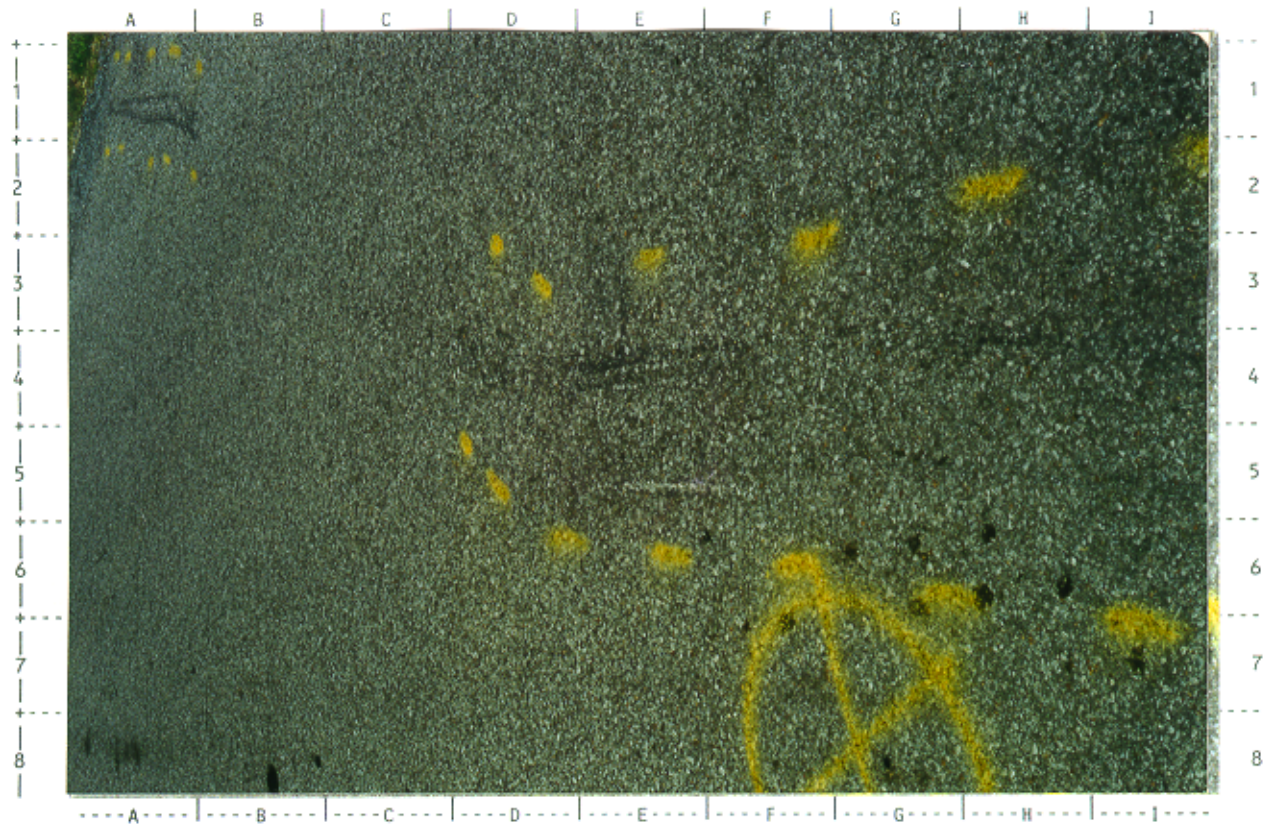
19 -- Close-up view of 1988 Chevrolet's LF skid and deflection marks along with gouge marks and POI circle--looking eastward

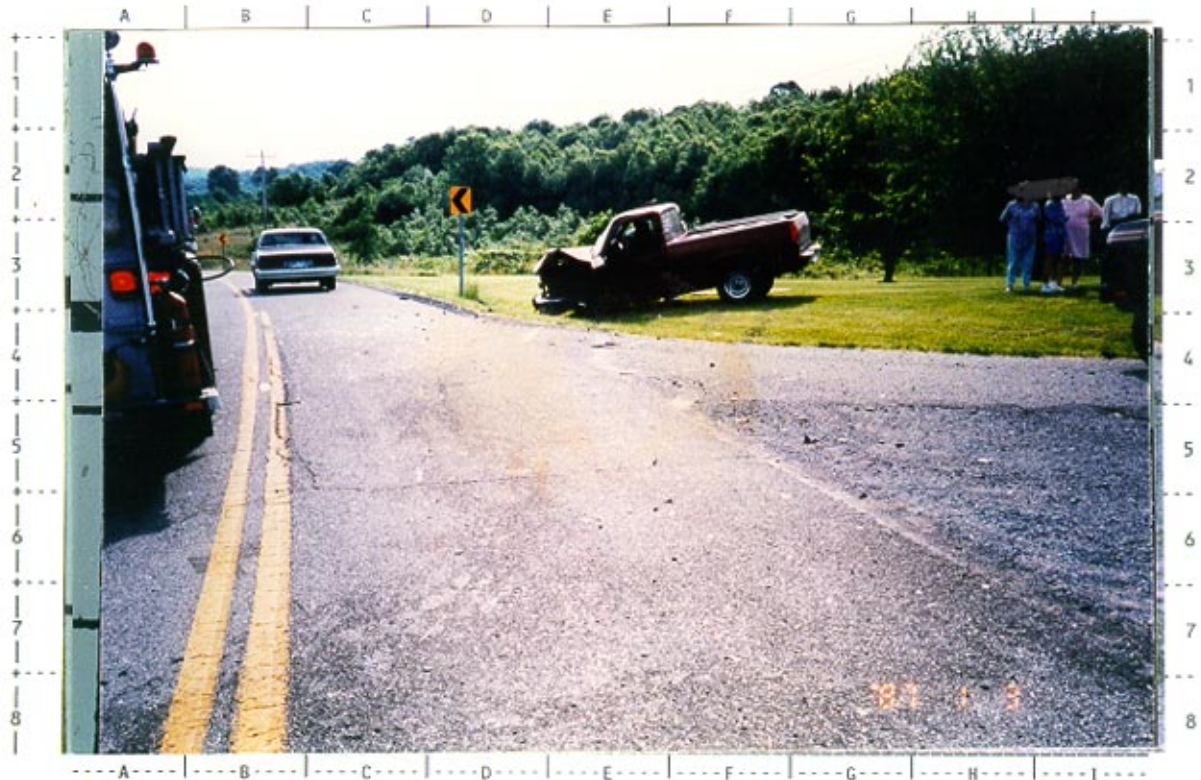
21 -- On-scene view of 1988 Chevrolet pickup's final rest position looking east--Chevrolet is heading north at FR on south shoulder

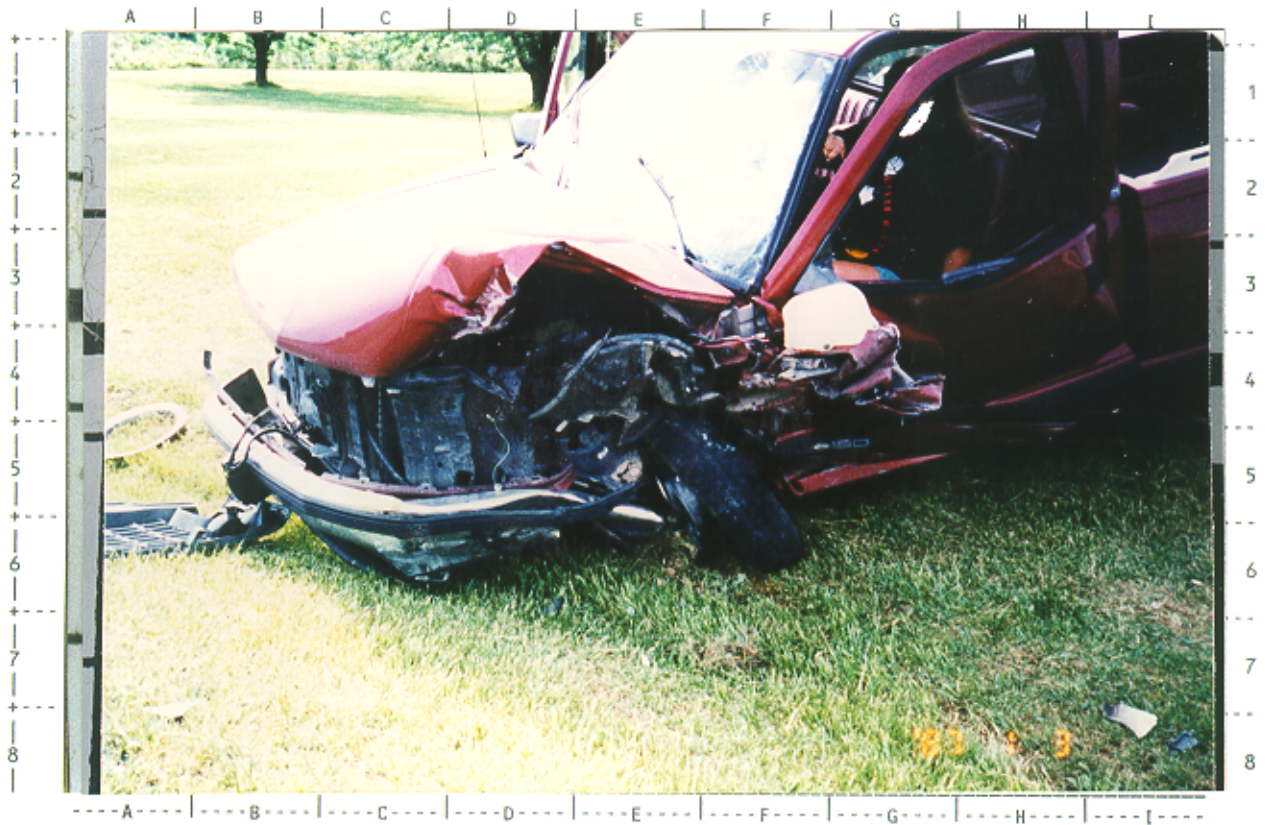
23 -- On-scene view of 1988 Chevrolet C-1500 pickup at final rest;
NOTE: driver is entrapped inside vehicle

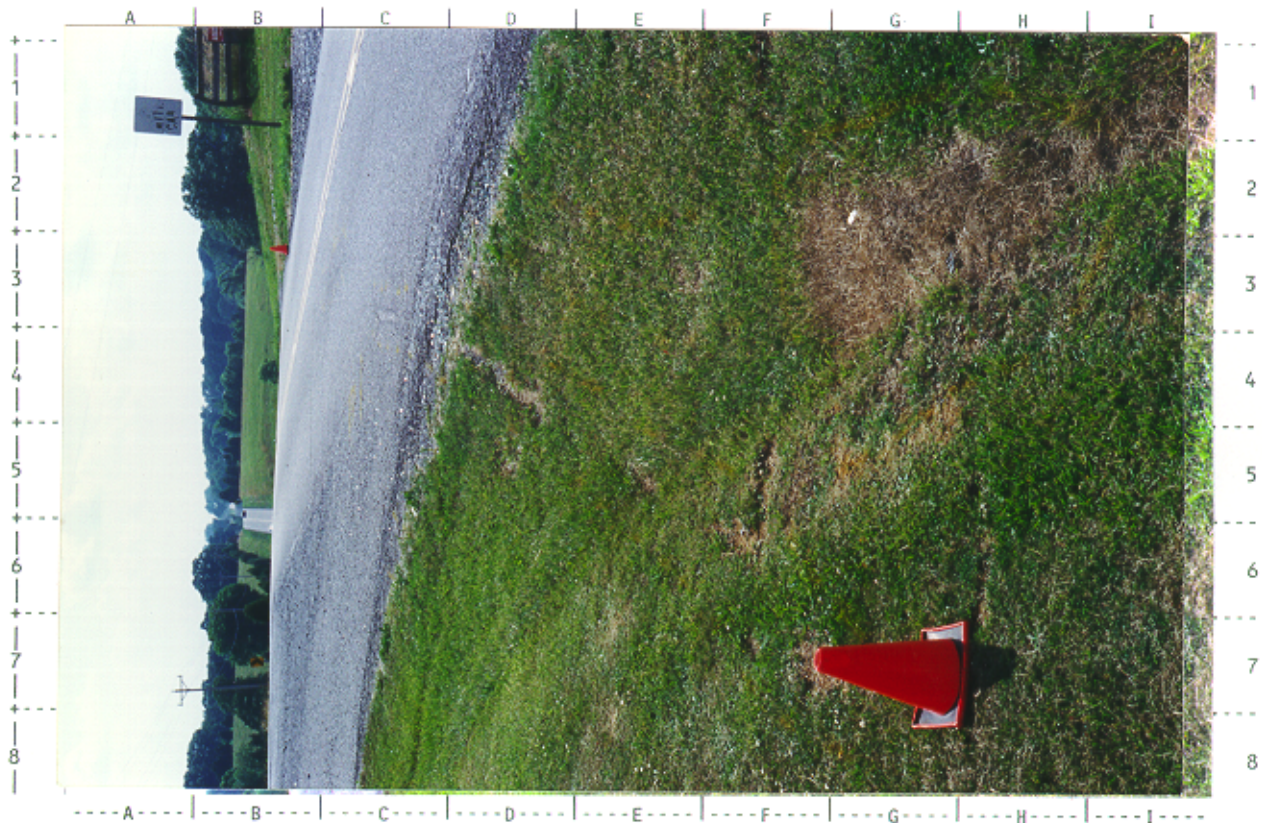
24 -- Northeast view of dead grass killed by radiator leakage from the
1988 Chevrolet C-1500 pickup at final rest
